Inspection Report Cook Islands

MV Maungaroa, Lady Moana and Grinna II

JULY 2019

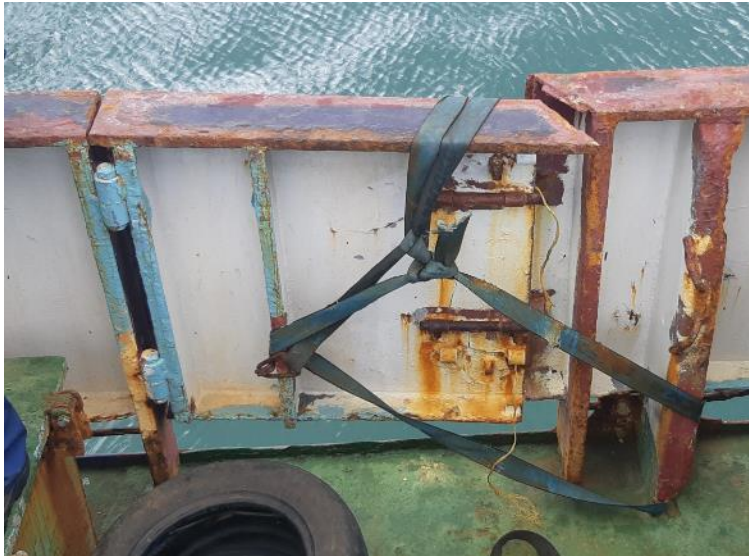
A number of smaller hatches did not close correctly and dogs/locking mechanisms were seized. Some fire and weather tight doors had electrical cords passed through. This appeared to be a permanent arrangement and may prevent the door being closed properly.

Figure 2 Access doors in bulwark not closing correctly.

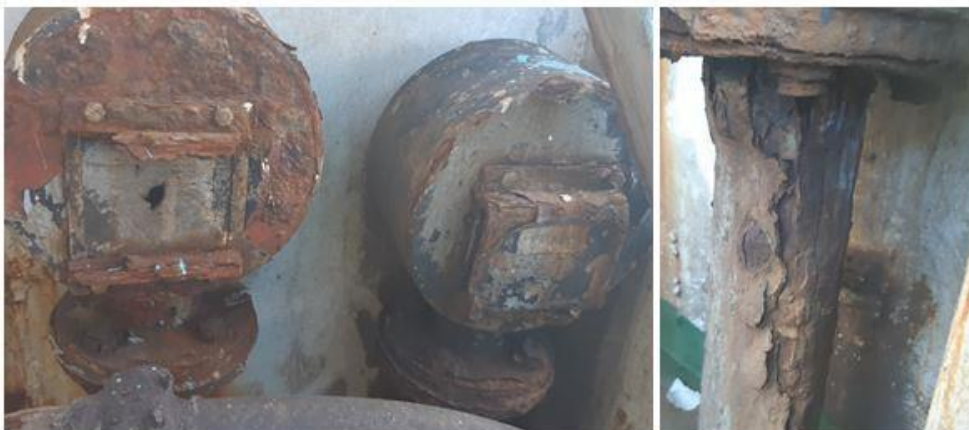
Figure 3 Heavy corrosion on starboard side fuel vents in area of gangway.

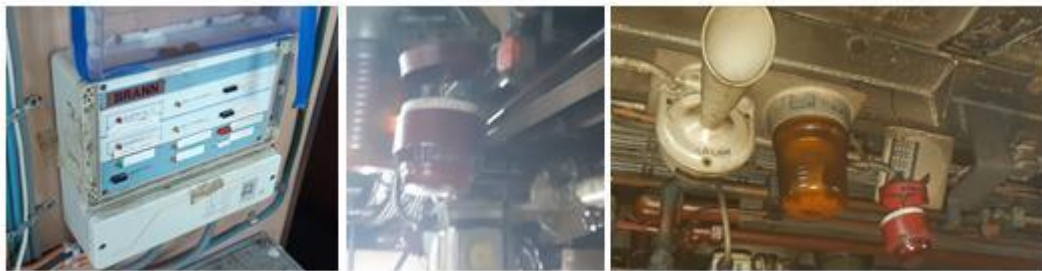
Figure 4 Fire Detection System.

Fire detection system is fitted but does not work in any space. Never tested by crew. Further inspection shows detection heads in very poor condition. It is likely this system has not worked for a long time.

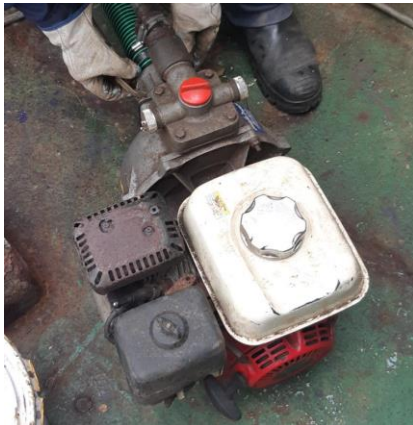
Figure 5 Emergency fire pump.

Pump could not be made to work when requested. The strainer required for intake was missing. This was fixed on the last day of the visit to the vessels (11 July).

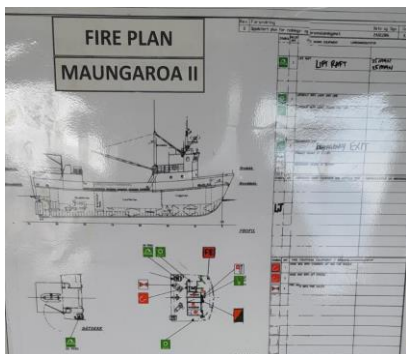
Figure 7 Fire control plan.

Fire control plan does not show the information required as per the IACS guidelines:

- Fire sections enclosed by A-Class divisions
- The ventilating systems
- Location of emergency stops for fuel tanks
- Extra copy of fire plan not found in external location for shore use

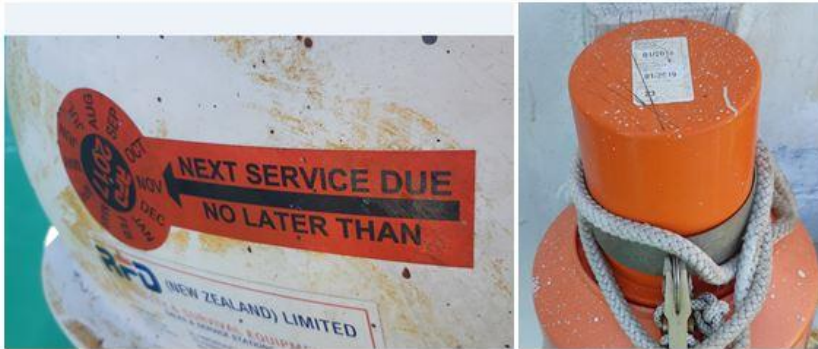
Figure 8 Liferaft and Lifebuoys expired.

Noted expired at time of inspection; some replacement parts did arrive in the following days however it should be noted that these items had expired at least 6 to 12 months earlier.

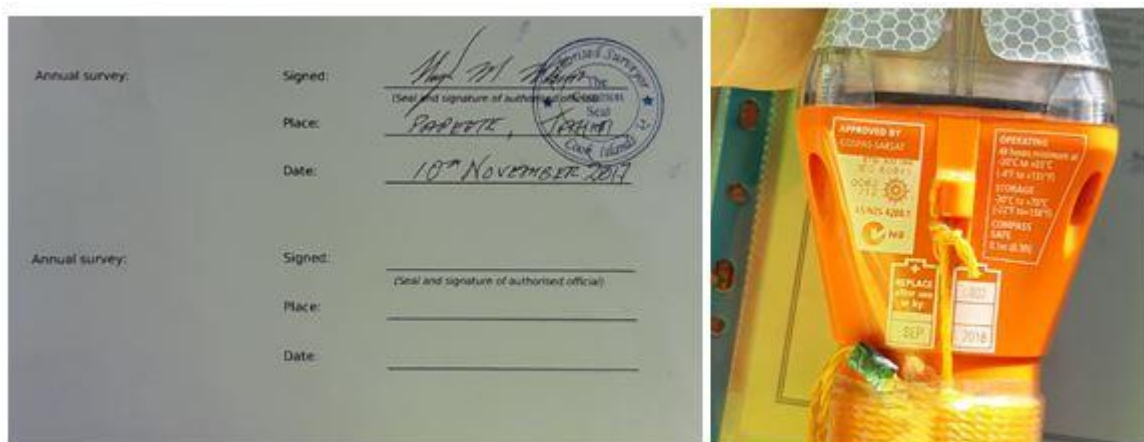
Radio installation section **does not apply** as the vessel is less than 300GT and not on international trade. A radio certificate was issued however the survey was not recorded if done for 2018.

Figure 9 Radio Equipment Certificate / Expired EPIRB.

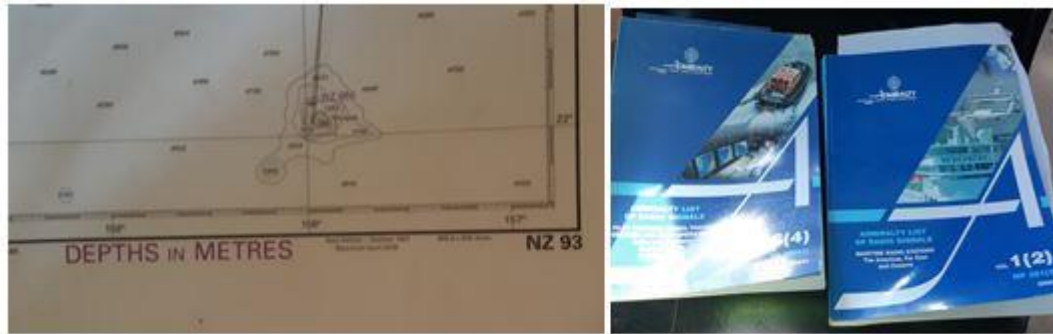
Figure 10 Charts and nautical publications.

Most of the charts are expired old editions and corrections have not been applied (in some cases since 2002). Nautical publications are provided but as old editions and again not corrected or up to date.

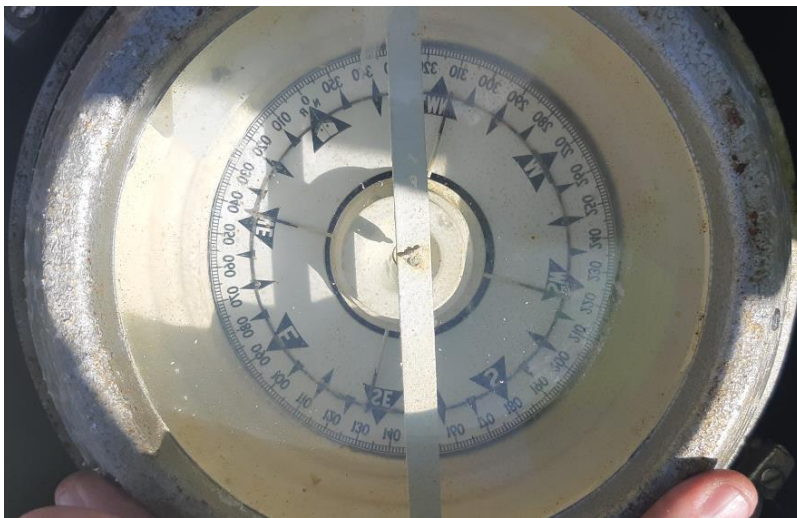
Figure 11 Ship's magnetic compass.

The compass was found to be completely dry. This is not in working condition and must be addressed. No spare compass found as required by SOLAS.

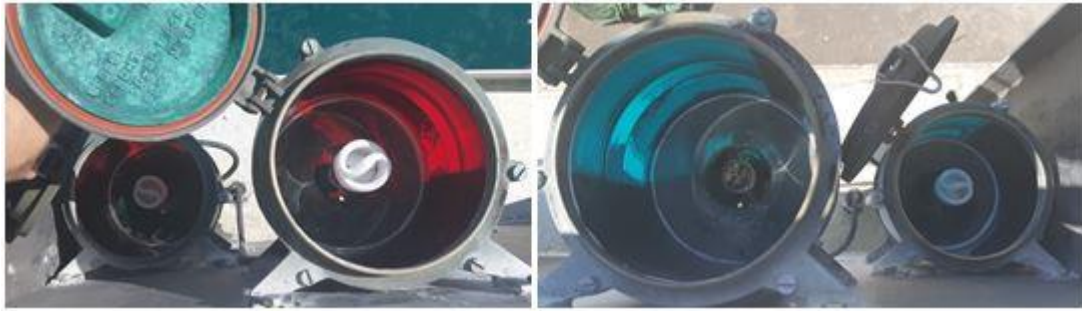
Figure 12 Navigational lights could not be shown to operate.

In addition to this, no ship's bell was found and no daytime signal shapes.

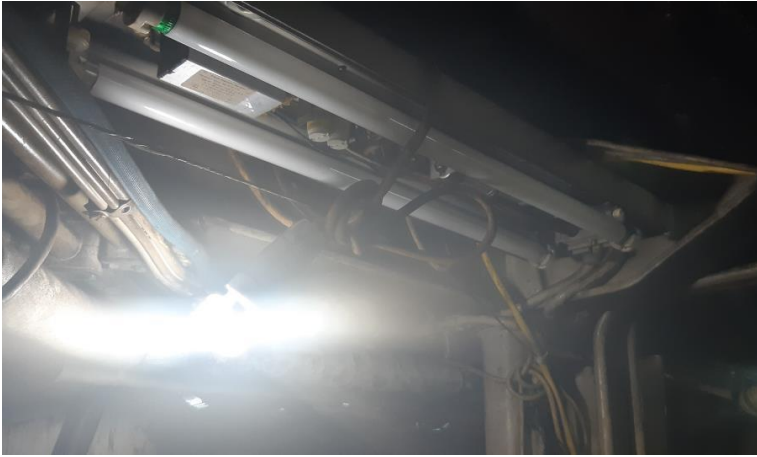
Figure 15 Lighting in engine room is broken. Power cords run to extra lights. This is unsuitable as doors cannot be closed fully to prevent fire. Demonstration of poor maintenance.

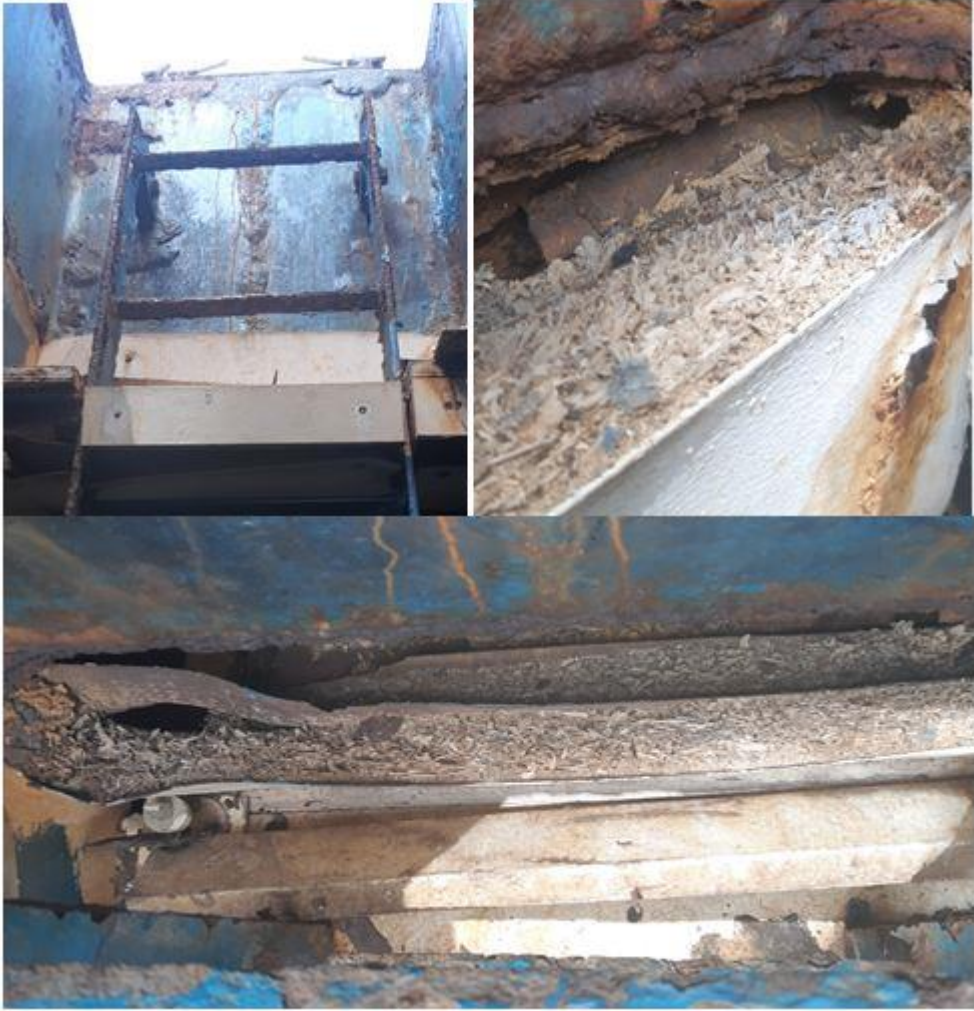
Figure 16 Corrosion in way of forward focsle hatch access from sleeping quarters.

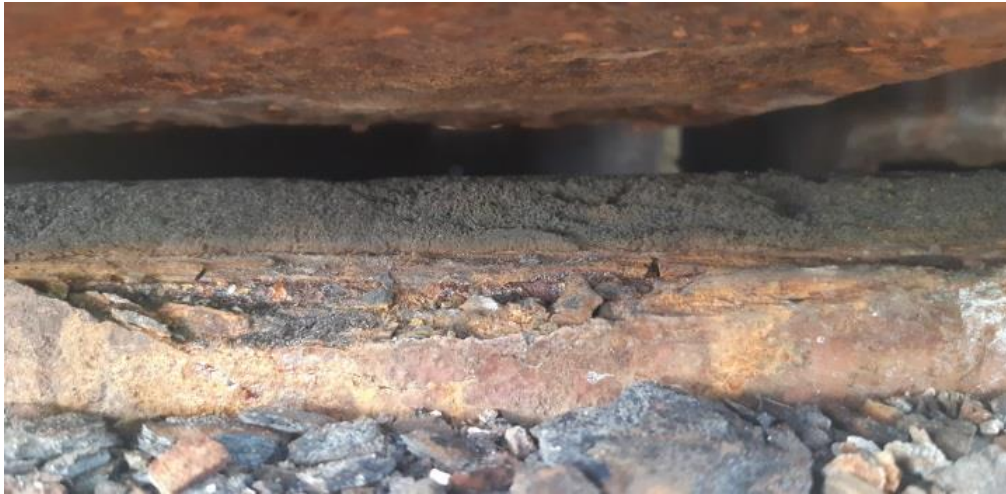
Figure 18 Cargo hatch does not seat correctly on the compression bar (port side).

Incorrectly seated hatch covers and broken locking mechanisms present a risk for flooding.

The hatch cover is not sealing and a number of hatches and vents are in poor condition. These should be assessed further and action taken if necessary to remedy.

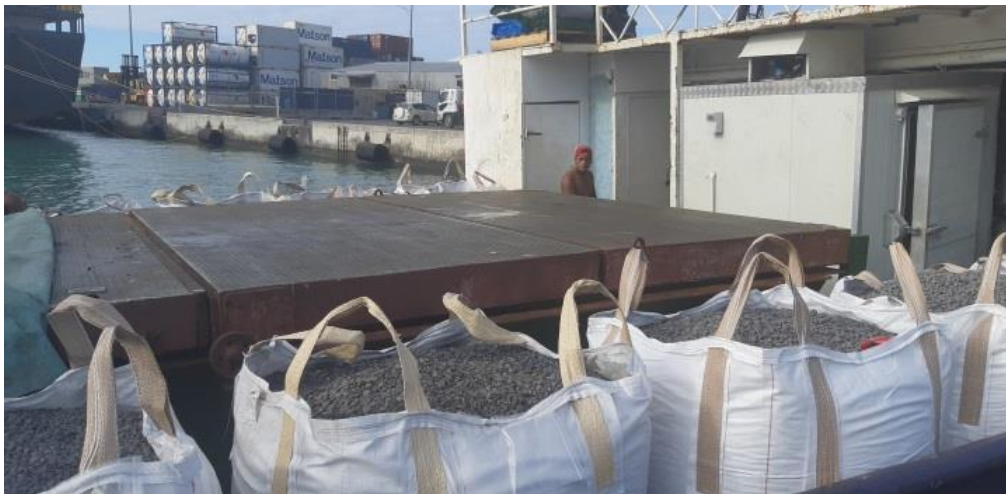
Figure 19 Vessel was carrying aggregate for construction. Loading plan was to load cargo on board until vessel on marks.

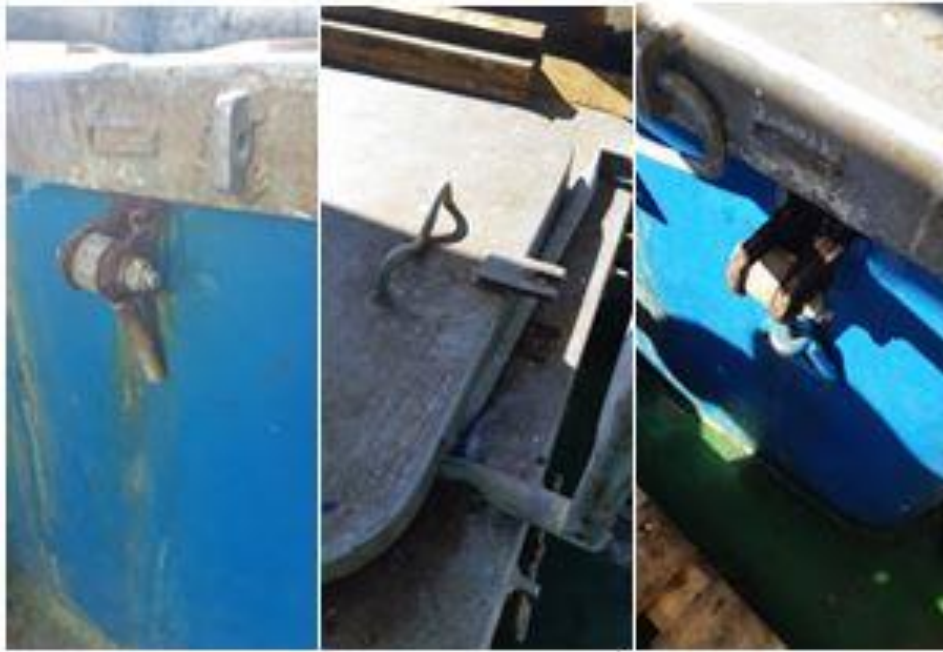
Figure 20 Smaller hatches (aft) missing securing cleats / dogs. Forepeak sounding pipe securing cleats broken. A number of doors with stiff dogs noted and electrical cords passed through.

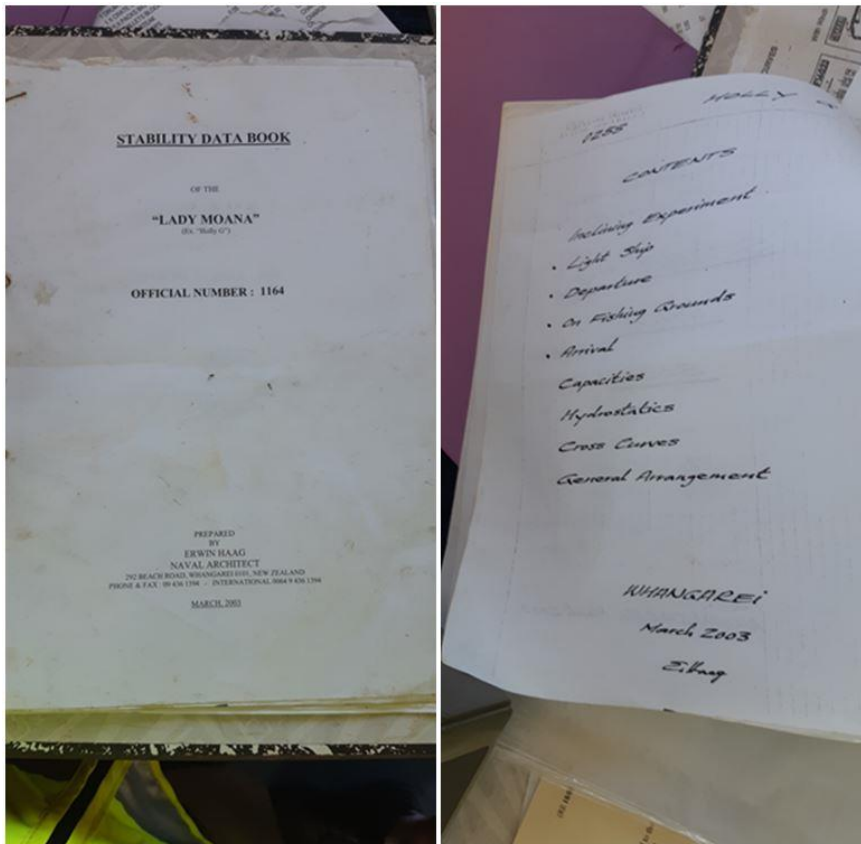
Figure 21 *Lady Moana* Stability Data Booklet.

The stability booklet provided for the vessel is from 2003. The booklet is produced on the basis of the vessel being used as a fishing boat.

This has not been the case for a number of years. The loading conditions are those for fishing.

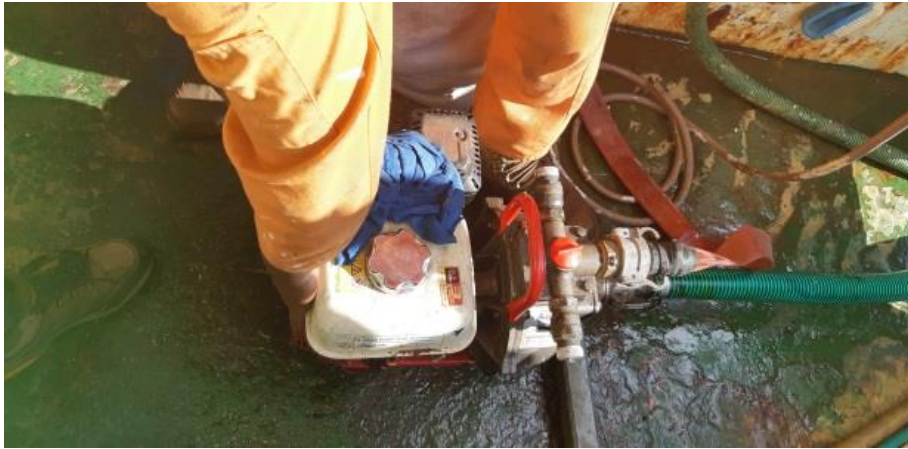
Figure 23 Emergency fire pump.

Portable fire pump does not work. Also the water uptake is not fitted with a strainer (Ref IACS Chapter IV - 1.1.3).

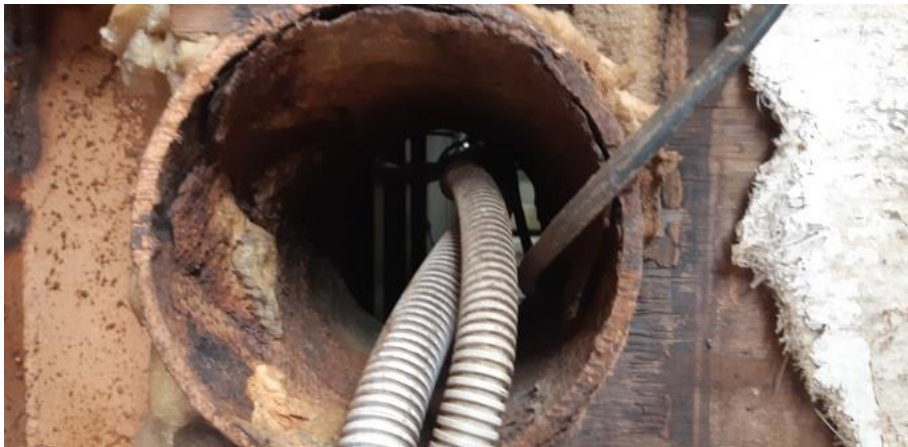
Figure 24 View into engine room from cargo space.

- Penetration in engine room bulkhead to cargo space (A-60 breach Ref Chapter IV - 2.1.1.6)
- No approved fire detection system found on board for cargo or machinery spaces (no Approval document under Section 7 for Alternative under Charter IV Section 7 noted)
- No fixed fire-fighting system found in the machinery space (Ref Chapter IV - 4.1)
- No fire-fighting outfit provided as per Fire Safety System (FSS) Code (Ref Chapter IV - 5.2)
- No self-contained breathing apparatus set on board (SOLAS II-2 reg 10)

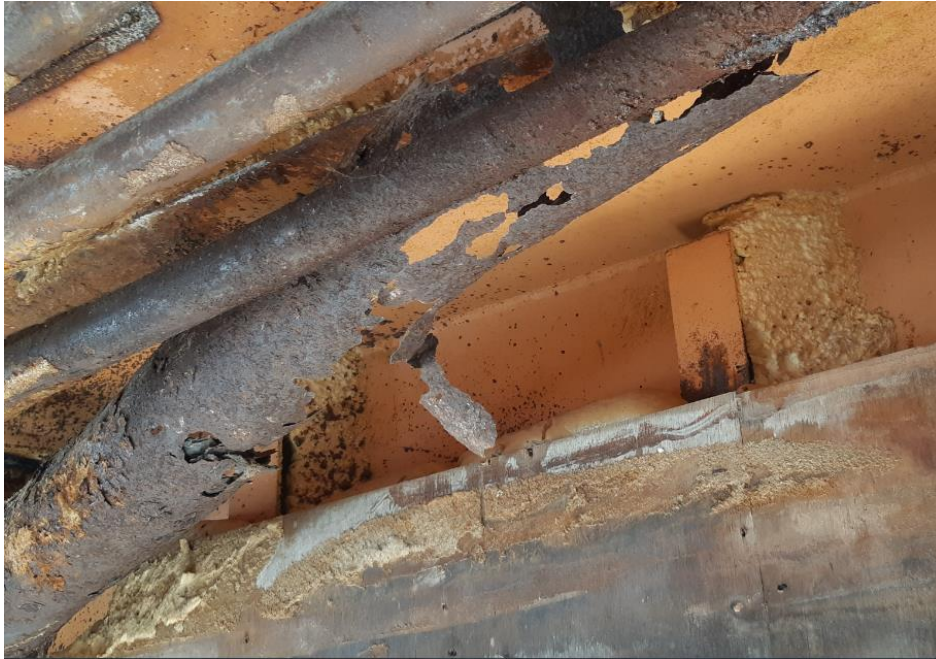
Figure 25 Corroded piping in cargo hold that leads to engine room ventilation.

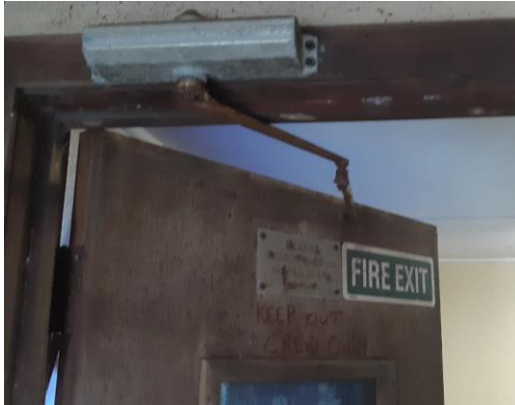
Figure 27 Hatch to engine room does not appear to be A-60 rated.

Door with self-closer separating engine room hatch from galley/mess room is wood and does not provide A60 protection.

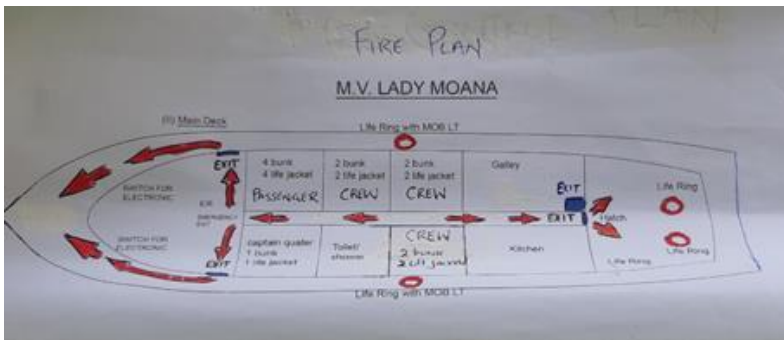
Figure 28 Fire plan provided on board, not in compliance with IACS recommendation.

Fire control plan does not show:

- Fire sections enclosed by A-Class divisions
- The fire extinguishing appliances
- The ventilating systems
- Location of emergency stops for fuel tanks
- Extra copy of fire plan not found in external location for shore use

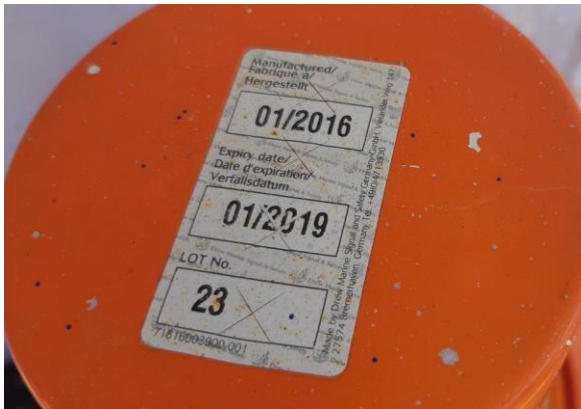
Figure 29 Bridge lifebuoy smoke float.

One lifebuoy on bridge wing smoke floats expired. Other bridge wing light not working and no smoke float provided. All rings in poor condition with faded retro tape.

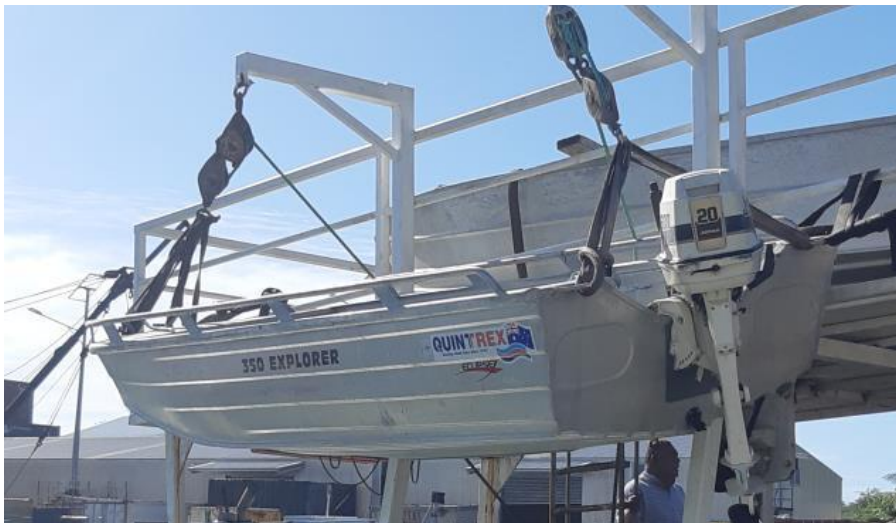
Figure 30 Aluminium boat is not a rescue boat.

Aluminium boat is not a rescue boat as per LSA code, specifically:

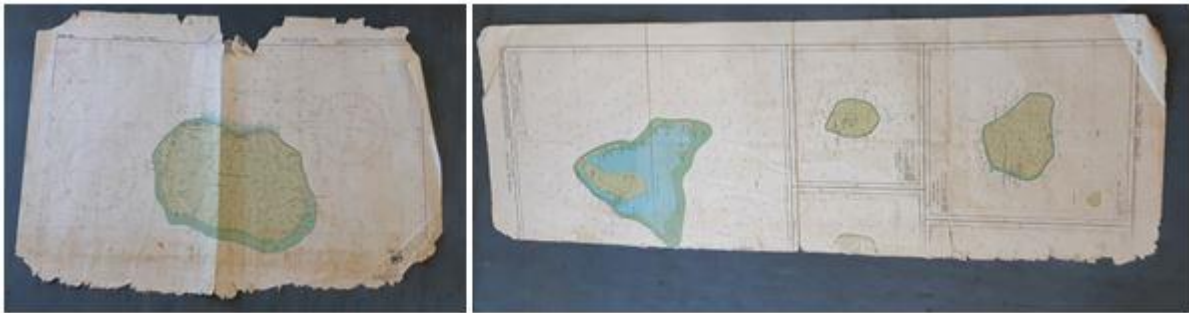
- No pelorus or compass bearing device
- Charts in very poor condition, not the latest edition and not corrected.

Figure 34 Charts in poor condition and not current.

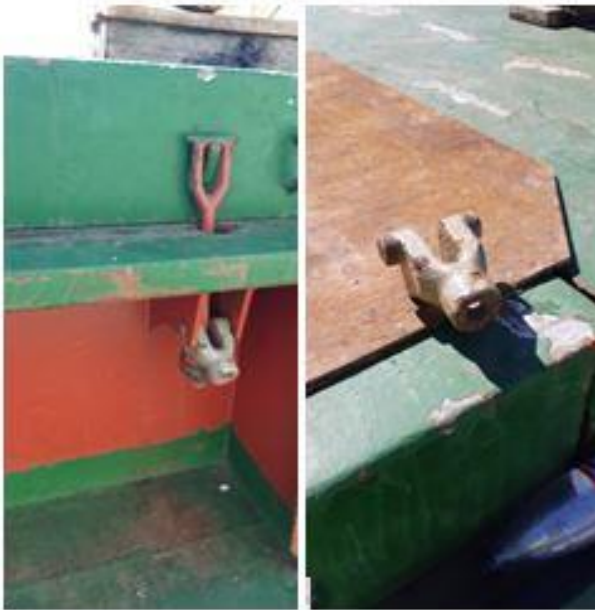
Figure 36 Cargo hatch securing dogs are not used by crew (rectified in inspection).

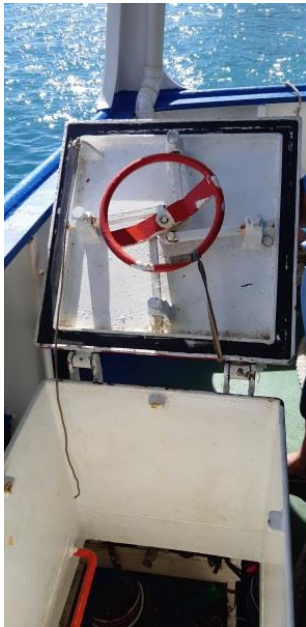
Figure 37 Aft hatch to steering gear not sealing – note this also has access to engine room which is typically not secured. Flooding into this space could also flood engine room.

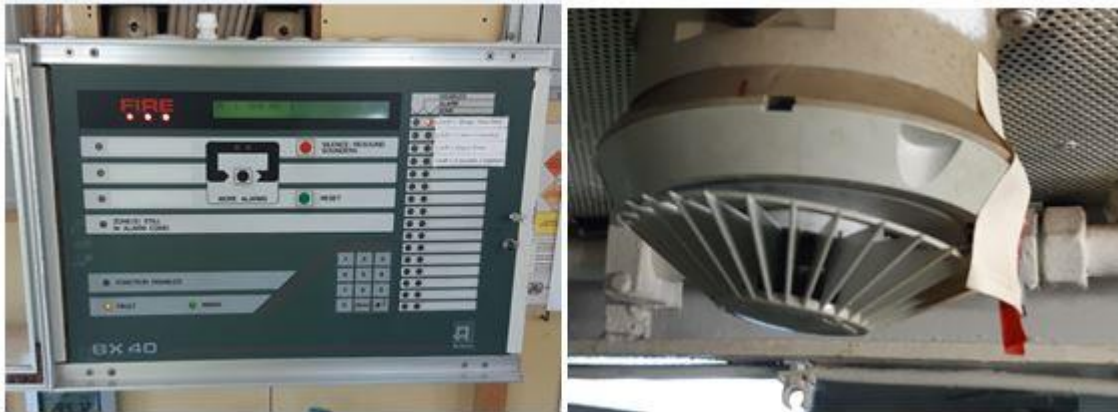
Figure 38 Fire detection system – main panel and engine room detector head.

The fire detection system was showing fault for all accommodation areas and a test of the engine room space could not activate the alarm in that space. System likely completely non-functional at this time.

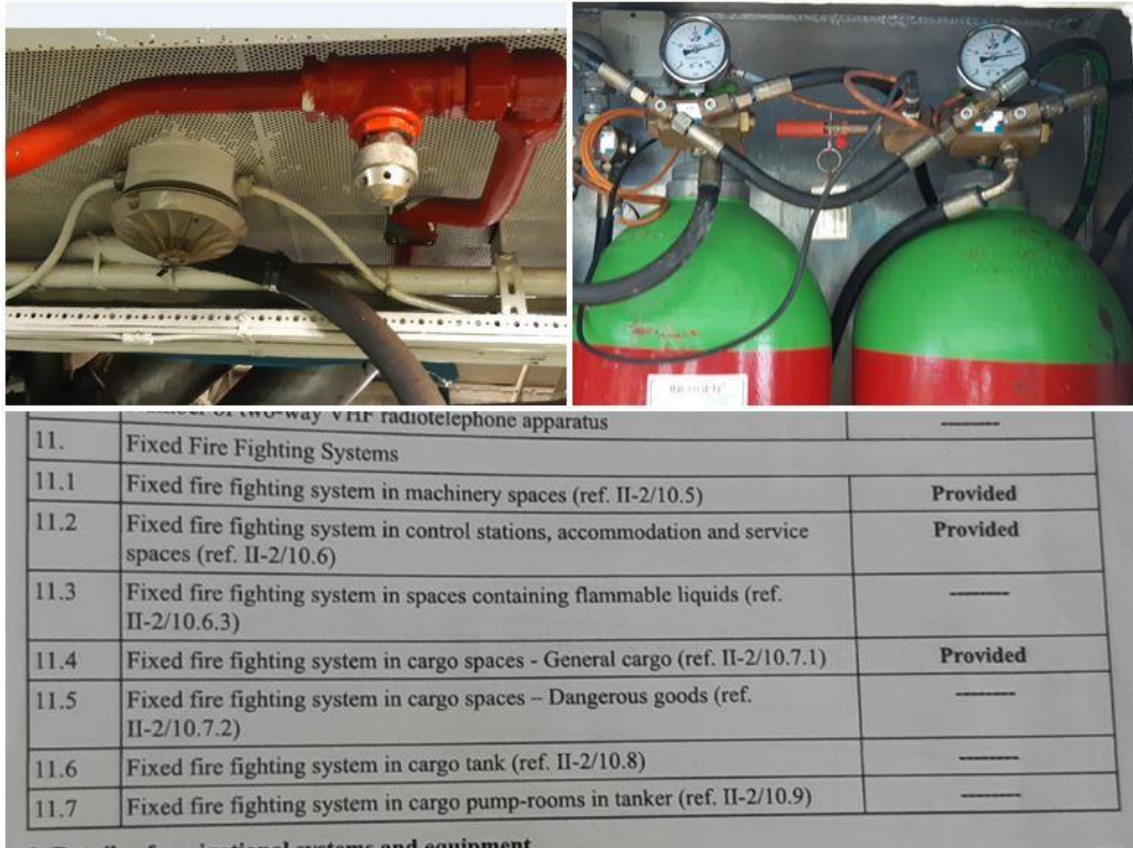
Figure 39 Fire Suppression System and Safety Equipment Certificate.

Vessel is fitted with an “INERGEN” fire suppression system that seems to be in working order however it should be noted that this system only covers the ship’s engine room. The Safety Construction Certificate issued by MCI states this extends to the cargo hold. From discussion, the vessel carries dangerous goods in the hold which would be a significant risk without a fixed suppression system.

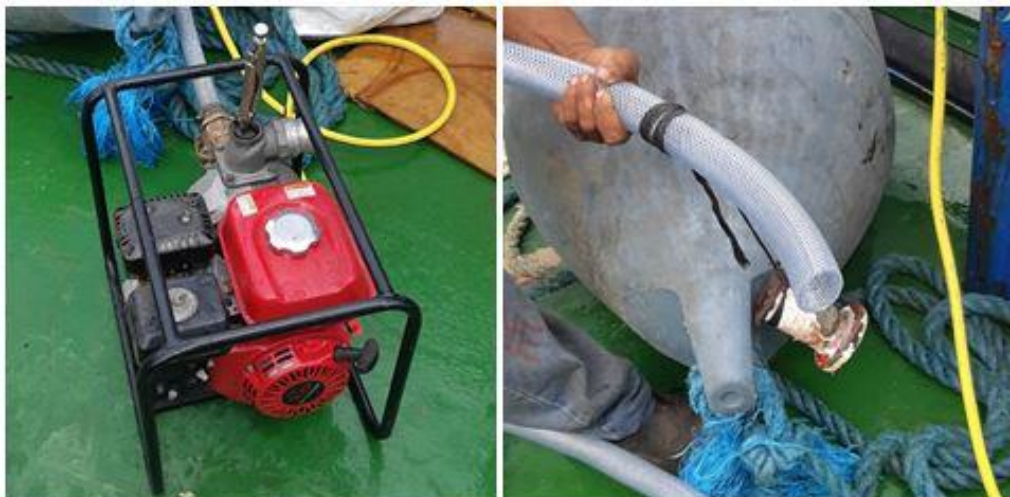
Figure 40 Emergency fire pump.

Pump could not be made to work when requested. Also, strainer required for intake was missing.

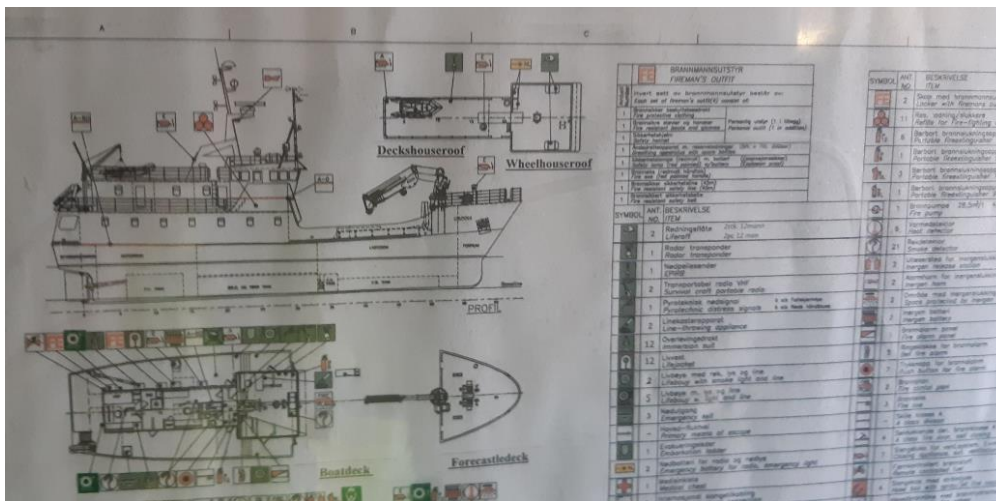
Figure 41 Fire control plan.

Fire control plan shows all equipment that was provided on delivery of the vessel when it was SOLAS compliant and does not accurately reflect current condition. This has not been stamped as approved by MCI.

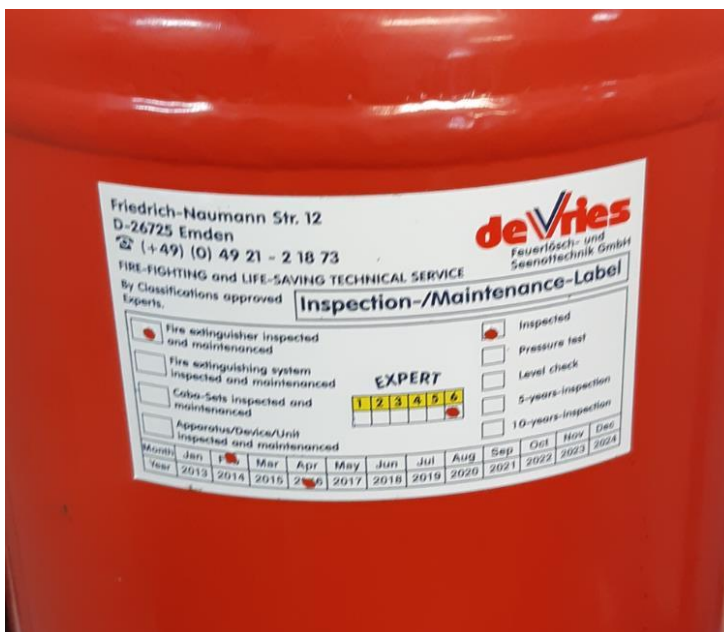
Figure 42 Extinguishers.

No evidence to show annual tests of the extinguishers has been done. Extinguisher shows last test done in 2016.

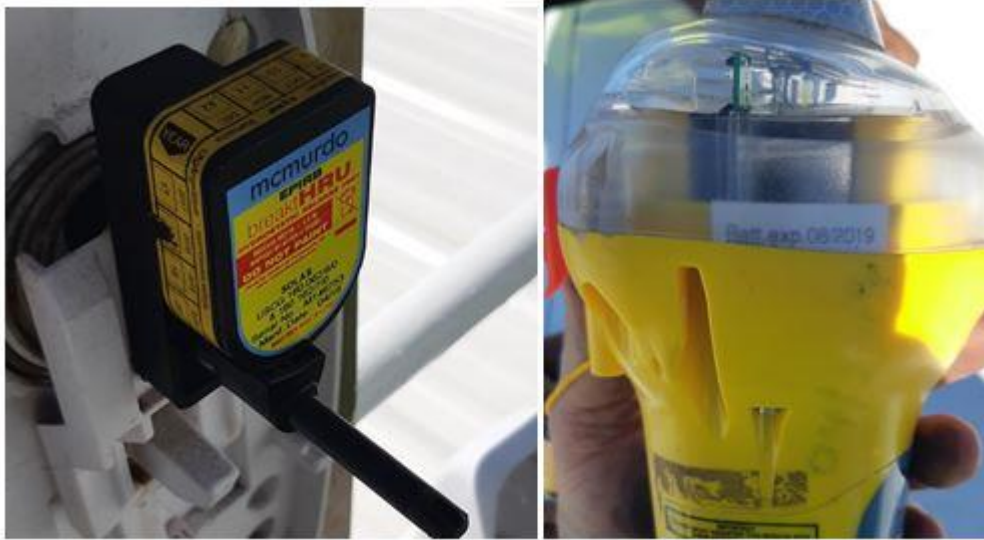
Figure 43 EPIRB Battery and release unit expired.

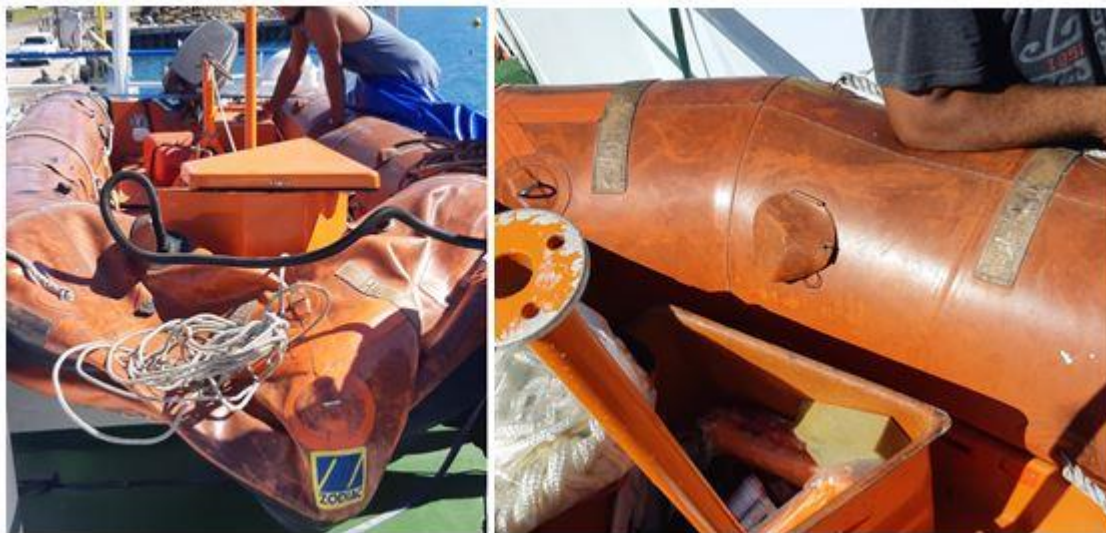
Figure 44 Rescue boat.

Rescue boat was noted to be in partially deflated condition. This would not be ready for immediate use in an emergency. Overall condition of the boat was poor and retro reflective tape needs to be replaced.

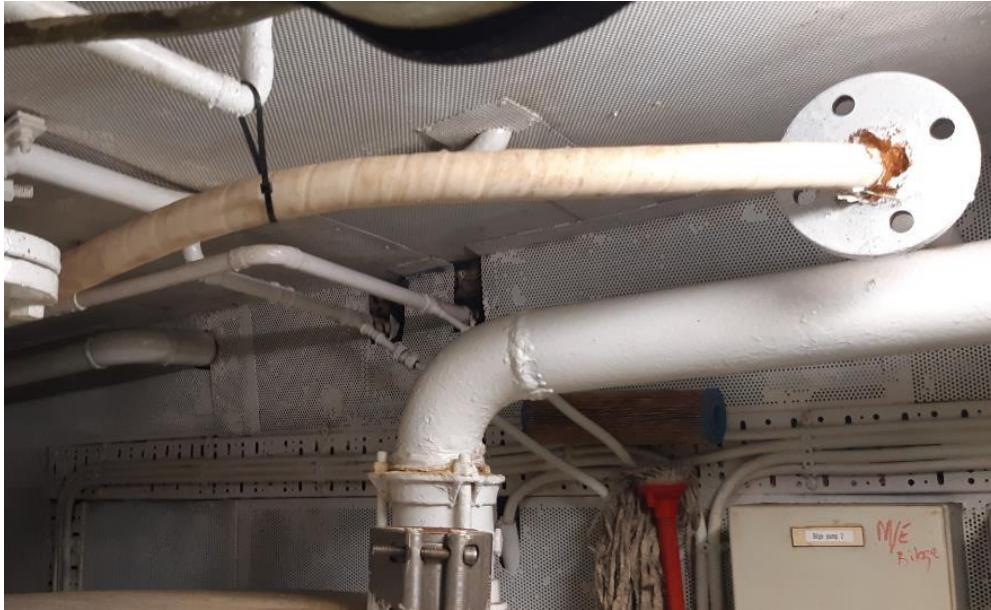
Figure 46 Sewage holding tank bypass for lower decks.
